This spreadsheet performs screening level calculations to estimate the effect of peeling leaded paint on the average concentration of lead in yard soil  
**3337 Willams Street**

Property ID: 184	Date: 8-18-05
Address: 3337 WILLIAMS STREET	Telephone #:
Owner:	CO Certification #: 12860
Inspector/Assessor:

## LBP Assessment Results

Property ID # 184 / 3337 Williams Street

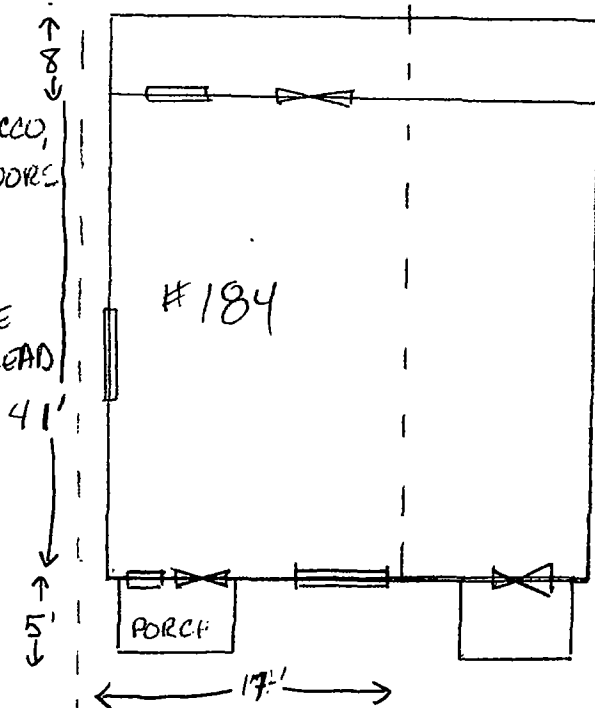
**Plot Plan:**

- TAN WALLS
- WHITE TRIM

HOUSE HAS NEW STUCCO, PAINT, WINDOWS & DOORS

MAJORITY OF HOUSE DOES NOT CONTAIN LEAD PAINT

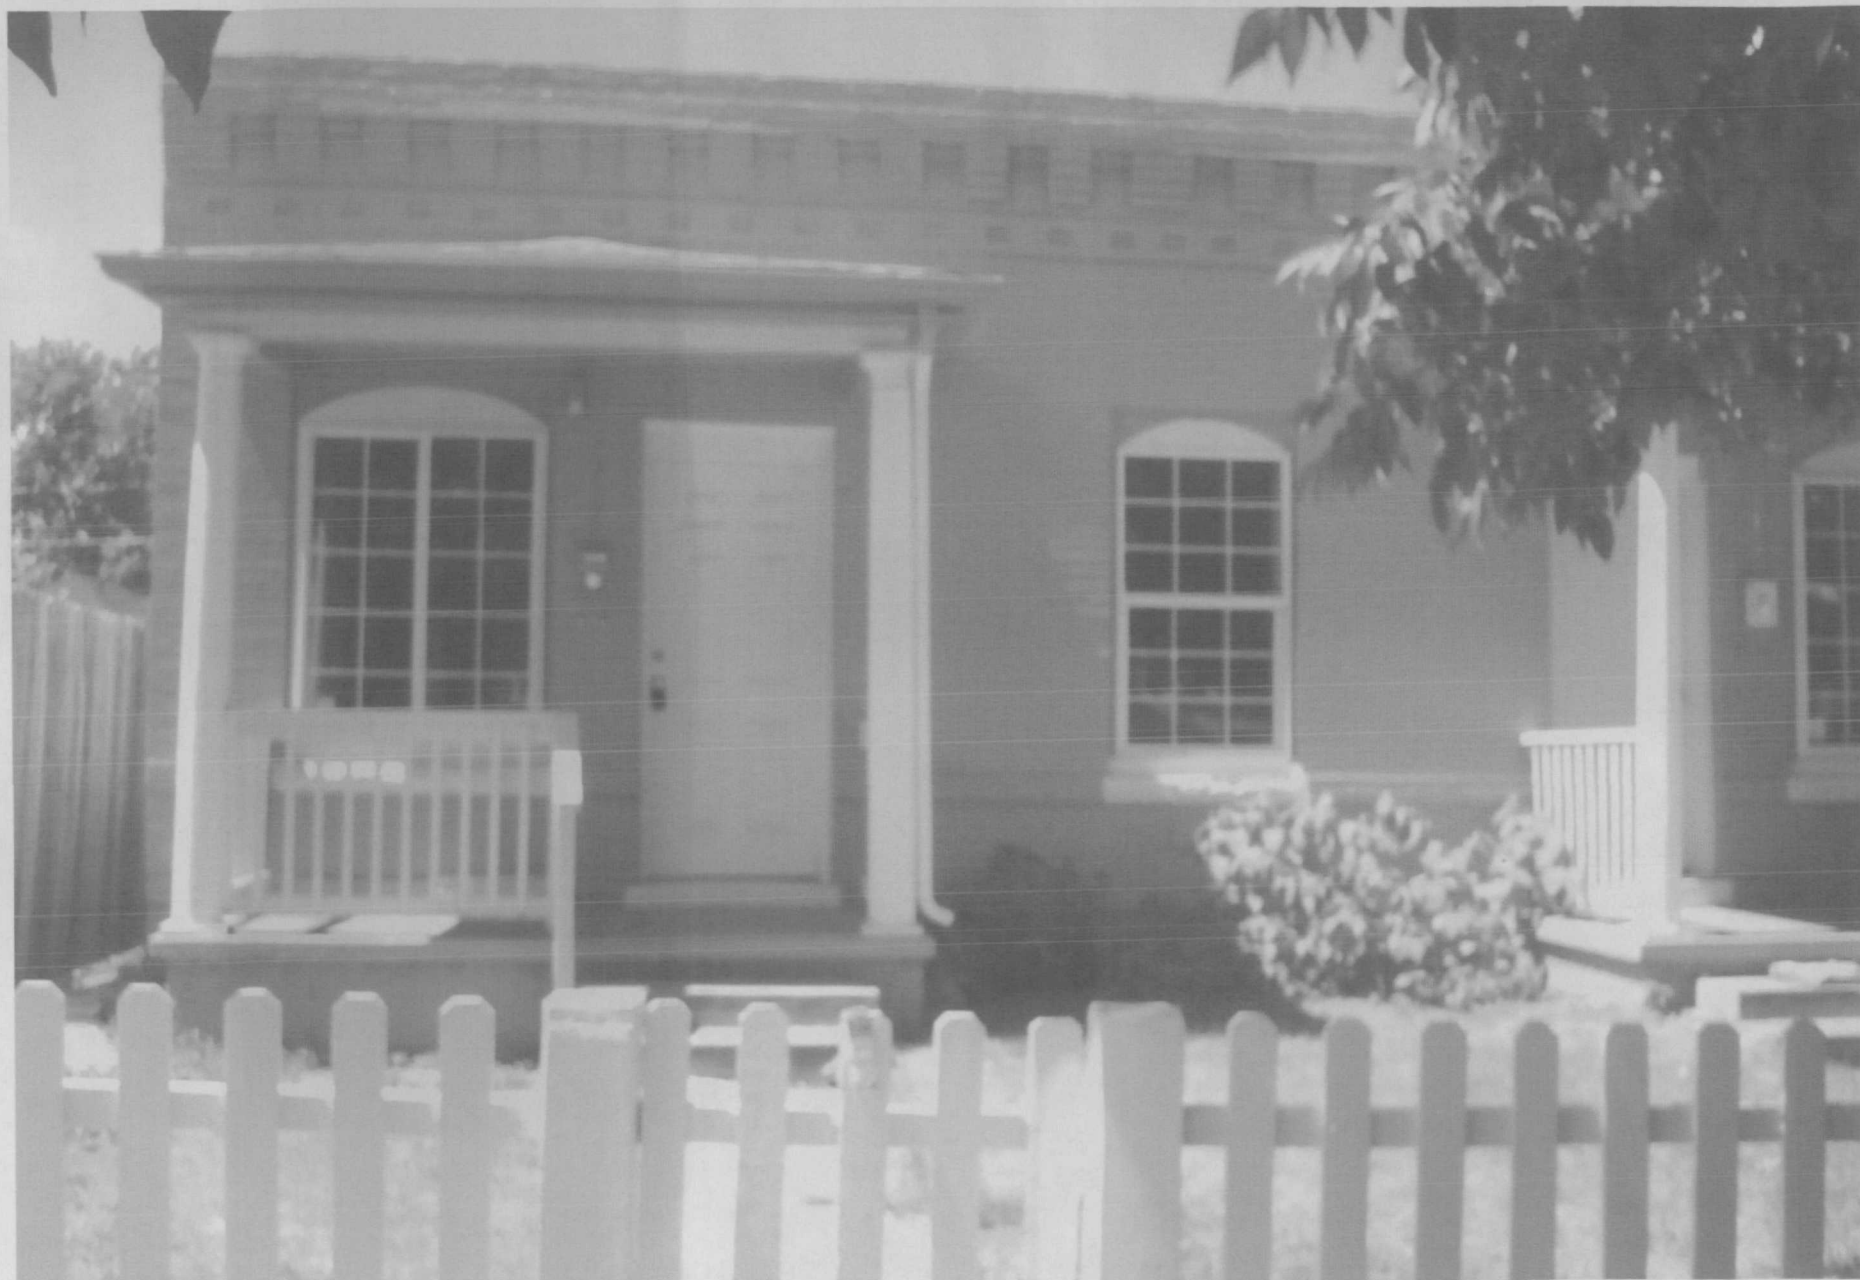
Majority of house does not contain lead paint
